Laser System Application

Nozzle Guide Vane Repair

Weld repair CF6-50 Nozzle Guide Vane

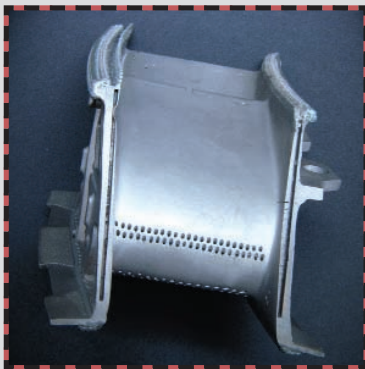
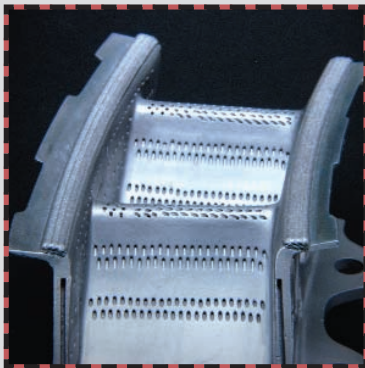
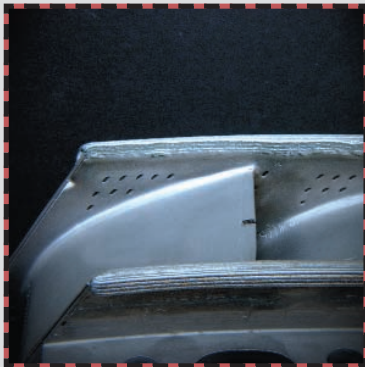
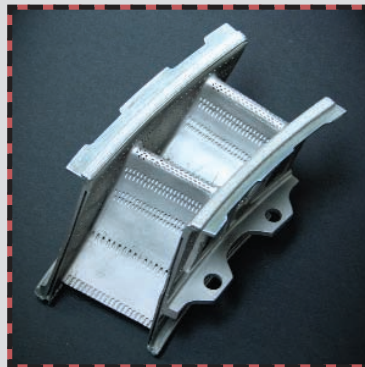
Precision application of appropriate weld material to forward flanges, aft rail and sides. Seven completed welds in one operation.
